# Investigation of the Technical Service Life of Cured-In-Place Sewer Pipe Liners

Results from Literature Review, Interview  
Campaign and Data Analysis

## Report of the SEMA Berlin 3 Project

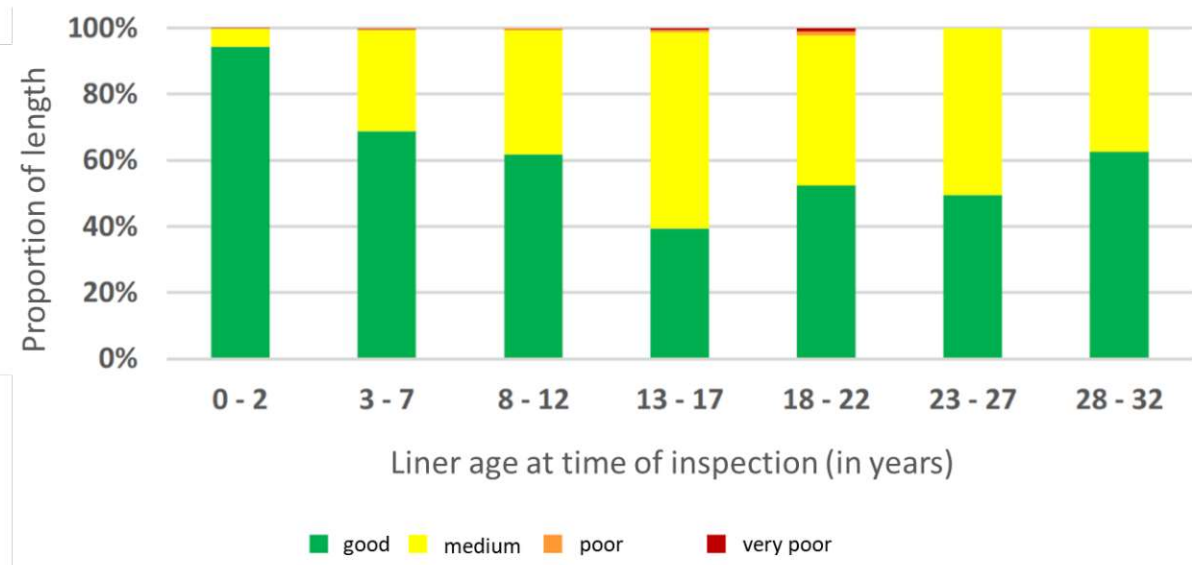
Figure 8: Condition distributions (ordinate) of the evaluated liners for the liner age groups at the time of inspection (abscissa); Figure from BWB

Based on the processed condition data, the SEMAplus condition distributions for different age groups, as shown in Figure 8, were determined. Across all analysed age groups, only 1.5 km of the examined liners are in poor or very poor SEMAplus condition (marked in orange or red). This corresponds to a very small proportion of just under 0.5% of the total examined liners. The most common types of damage found in these two rehabilitation-relevant SEMAplus condition categories include leaks, shards (holes in the liner with visible "liner fragments"), deformations, surface damage, material wear, and root intrusion. The latter remains classified in the poor SEMA category due to the incomplete review of all inspection videos. Overall, the proportion of liners requiring rehabilitation within each age group is low.

In Figure 8, a trend can be observed in the increasing proportion of liner lengths in the medium SEMAplus condition (marked in yellow) up to the age group of 13-17 years. According to data analysis, more than 95% of this deterioration is due to pre-existing damage that was rehabilitated using the liner, affecting approximately 165 km of liners classified in the medium condition category out of the total 332 km examined. This includes the previously mentioned manhole connection damages, which impact around 45 km of liners.

An interesting observation in Figure 8 is the trend of increasing shares of sections in good SEMAplus condition for age groups beyond 18 years. However, the representativeness of data in these older age categories is limited due to the significantly lower number of liners. Consequently, only the condition distributions of liners up to 17 years old will be used as the basis for deriving an updated liner survival curve. This trend provides a suitable foundation for adjusting the survival curves for liners used by Berliner Wasserbetriebe, as described in the introduction (Chapter 1), within the scope of available data. The assumptions derived from this data analysis for Berliner Wasserbetriebe and used for this adjustment are described in the following sections.
