# Emissions from Building Materials—A Threat to the Environment?

**Abstract:** A large variety of substances are used in building materials to improve their properties. In recent years, attention to organic additives used, for example, in renders, façade paints or roof sealing sheets has increased as these compounds have been detected in urban stormwater runoff and surface waters. In this paper, we show the extent of emissions induced by rain events in two study sites in Berlin. For this purpose, stormwater runoff from roofs, façades, and in storm sewers was sampled and analysed over a period of 1.5 years in two residential catchments. Results show that, in particular, the biocides diuron and terbuthryn from façades, the root protection agents mecoprop and MCPA in bituminous sheeting, and zinc from roofs and façades reach concentrations in the stormwater sewer that exceed limit values for surface waters. Additionally, transformation products of the biocides were also detected. However, many other analysed substances were below the quantification limit or inconspicuous in their concentration levels. The emissions, modelled with the software COMLEAM, demonstrate that in urban areas

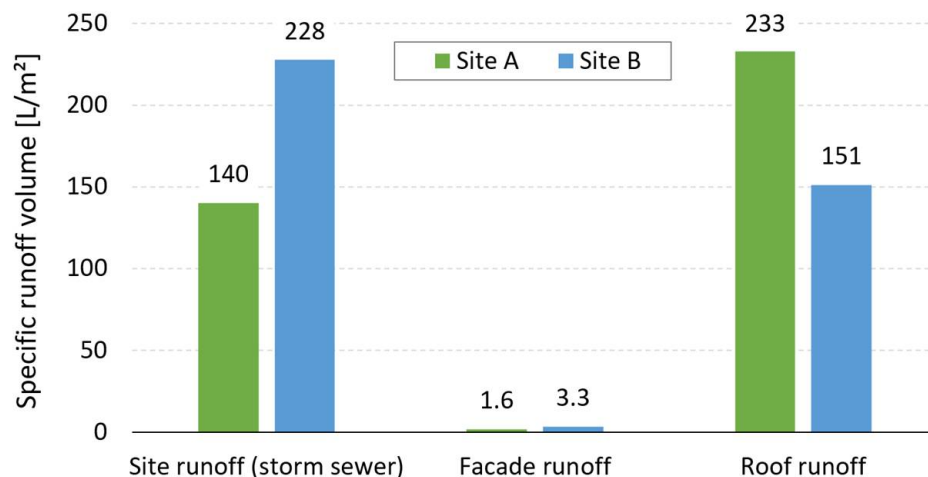
**Figure 1.** Specific runoff from surfaces drained to the storm sewer resulting from analysed storm events in test sites A and B.

The specific runoff volumes ( $L/m^2$ ) from surfaces connected to the storm sewer (site, roofs, and façades) are shown in Figure 1 for all analysed events. The lower specific site runoff at site A reflects the presence of grass grid stones for parking lots with much lower runoff. The specific roof runoff at site B is lower compared with site A due to the water retention of the green roofs in site B. The higher specific façade runoff at site B is caused by a larger fraction of façade area facing west (main wind direction) compared with site A. However, façade runoff volumes are very low, comprising <1% of the site runoff measured in the storm sewer.

The comparison of the specific façade runoff ( $L/m^2$ ) for all storm events with stormwater volume data ( $n = 70$ ) shows that the cumulated specific runoff from façades oriented to the west (site A:  $8.1 L/m^2$ , site B:  $12 L/m^2$ ) is about twice as high compared with the runoff from façades facing north and south (see Figure A5). This is clearly associated with westerly wind directions during rain events (Figure A6). Higher specific runoff from the west façades at site B can mainly be attributed to a larger distance of the building to interfering structures (i.e., buildings, trees). The lowest cumulated specific runoff was measured at façades directed to the east (about  $2 L/m^2$  for both sites).

Concentrations of organic micropollutants in stormwater runoff of the entire site (storm sewer) are shown in Figure 4. At site A, the highest concentrations were measured for mecoprop with a maximum concentration of 62 µg/L. Mecoprop concentrations were in the same order of magnitude as in the roof runoff (Figure 3), as a large proportion (67%) of the site runoff is contributed by the roof drainage (Figure 1). In contrast, the MCPA

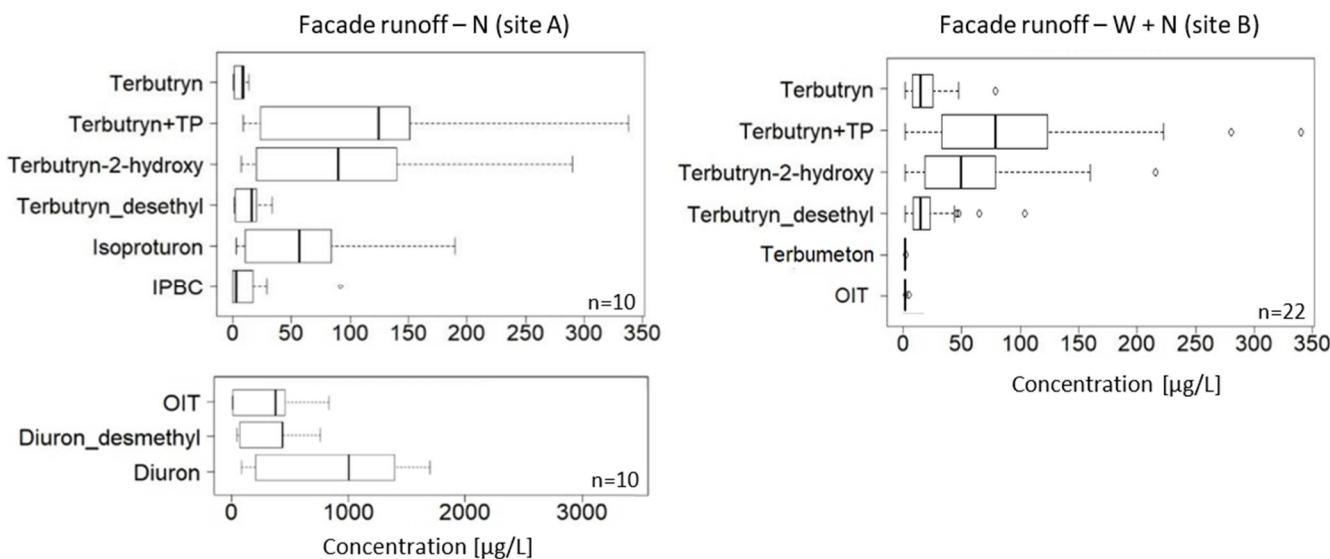
**Figure 2.** Concentration of biocides in façade runoff of painted façades at site A (north) and B (west and north).

The concentrations in façade runoff are shown in Figure 2. For site A, only concentrations in the runoff from north façades are shown, as west façades were not painted and consequently did not contain biocides (Figure A7). However, the concentrations of diuron and OIT (film protection agents in plaster product) were similar in both runoff from the north and west façades (see Figure A7 for results of west façade). For site B, runoff from the west and north façades show the highest concentrations for diuron (mean:  $900 \mu g/L$ ), its transformation product diuron-desmethyl (DCPMU; mean  $375 \mu g/L$ ), and OIT (mean:  $350 \mu g/L$ ). No trend towards a decrease in concentration was evident in façade runoff during the time of field investigation.

Concentrations of diuron in façade runoff 1.5–3 years after application as measured in this study correspond well to concentrations of façade runoff from test façades after one year of exposure (1–3 mg/L) reported by Burkhardt et al. [8]. Diuron-desmethyl (DCPMU) has been detected in façade runoff of site A as a degradation product of diuron at concentration levels approximately one third of the diuron concentrations. Transformation of diuron to diuron-desmethyl has been described in previous studies [8,18].

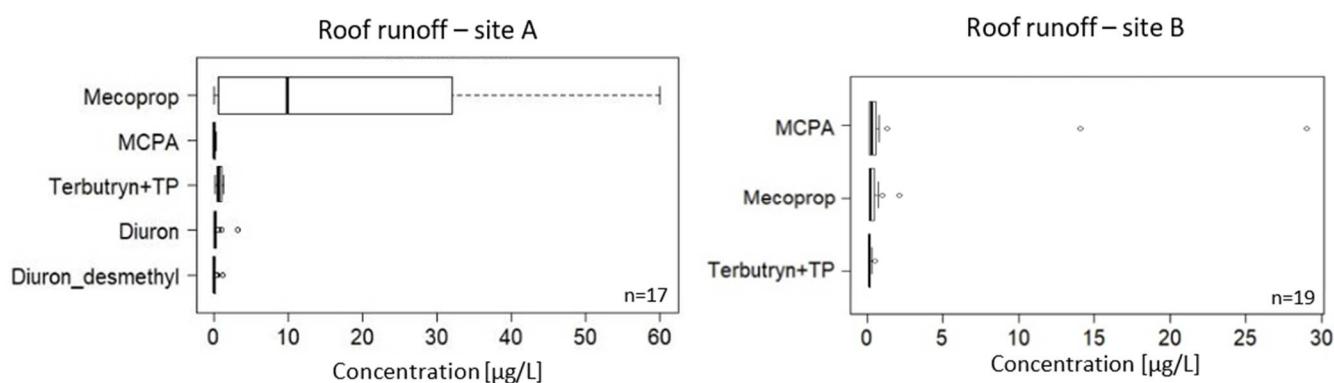
**Figure 3.** Concentration of organic trace pollutants in roof runoff at site A and B.

Roof runoff at site A was clearly dominated by the root protection agent mecoprop, resulting in a mean concentration of 20 µg/L (Figure 3). This is remarkable, as site A has no green roof and therefore does not require a protection against root penetration. Furthermore, recommendations by the Berlin authorities for the application of bituminous roofing membranes suggest the application of products with root protection only when necessary (e.g., for green roofs) [19]. The concentrations measured in the roof runoff of site A are in the same range as those reported by Bucheli et al. [5] in the roof runoff of two flat roofs with bituminous roofing membranes (average 3.3 µg/L, max. 35 µg/L). The concentrations of the root protection agent MCPA were low and close to the limit of detection, as it is not applied in the existing membrane. Low concentrations of diuron, terbutryn, and their transformation products were also detected (<0.5 µg/L, Figure 3, left), but at much lower concentrations than in façade runoff. Small, coated surfaces in the roof area could be potential sources.

MCPA present in bituminous sheets at site B was detected only in two rain events at concentrations >5 µg/L (15 and 30 µg/L, Figure 3, right). Similar to site A, low concentrations of terbutryn and its transformation products (<0.3 µg/L) are likely due to small painted surfaces in the roof area.

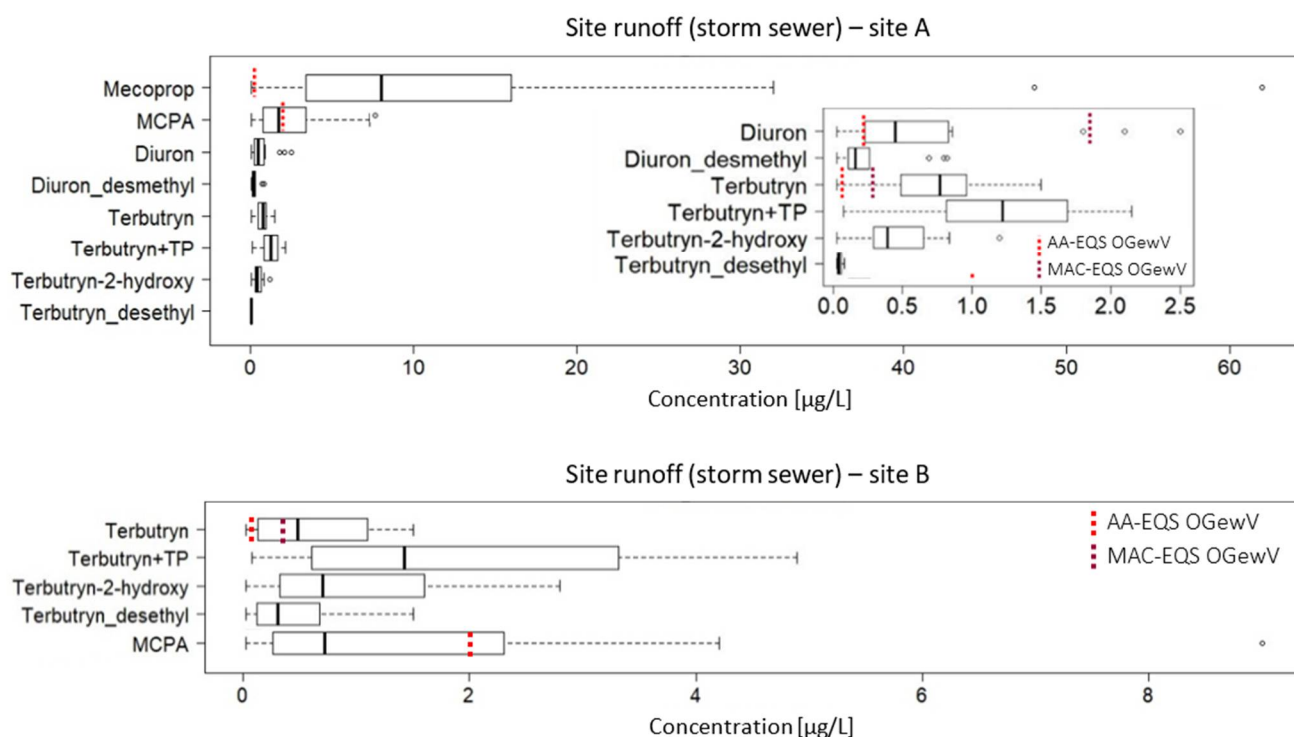
**Figure 4.** Concentration of micropollutants in site runoff (storm sewer) of site A and B.

Concentrations of diuron and terbutryn varied between 0.2 and 2.5  $\mu\text{g/L}$ . These are higher compared with stormwater runoff from larger urban catchments of different land uses [11]. This is plausible as stormwater runoff in our study originates exclusively from sites with new buildings constructed about 1.5 years before monitoring began; whereas, larger urban catchments comprise of buildings of different age containing different construction materials. On the other hand, concentrations of terbutryn in stormwater runoff are well in line with concentrations of Bollmann et al. [13], measured in the stormwater runoff of a residential catchment in Denmark (mean: 0.1  $\mu\text{g/L}$ , max 1  $\mu\text{g/L}$ ). In contrast to diuron and terbutryn, OIT, IPBC, and isoproturon, occurring in the façade runoff (Figure 2), were hardly detected in the storm sewer samples. In the case of OIT and IPBC, this has also been described by Burkhardt et al. [20], who concluded that OIT and IPBC released from façades do not lead to surface water pollution due to the rapid transformation of both biocides (half-life  $DT_{50} < 3$  days).

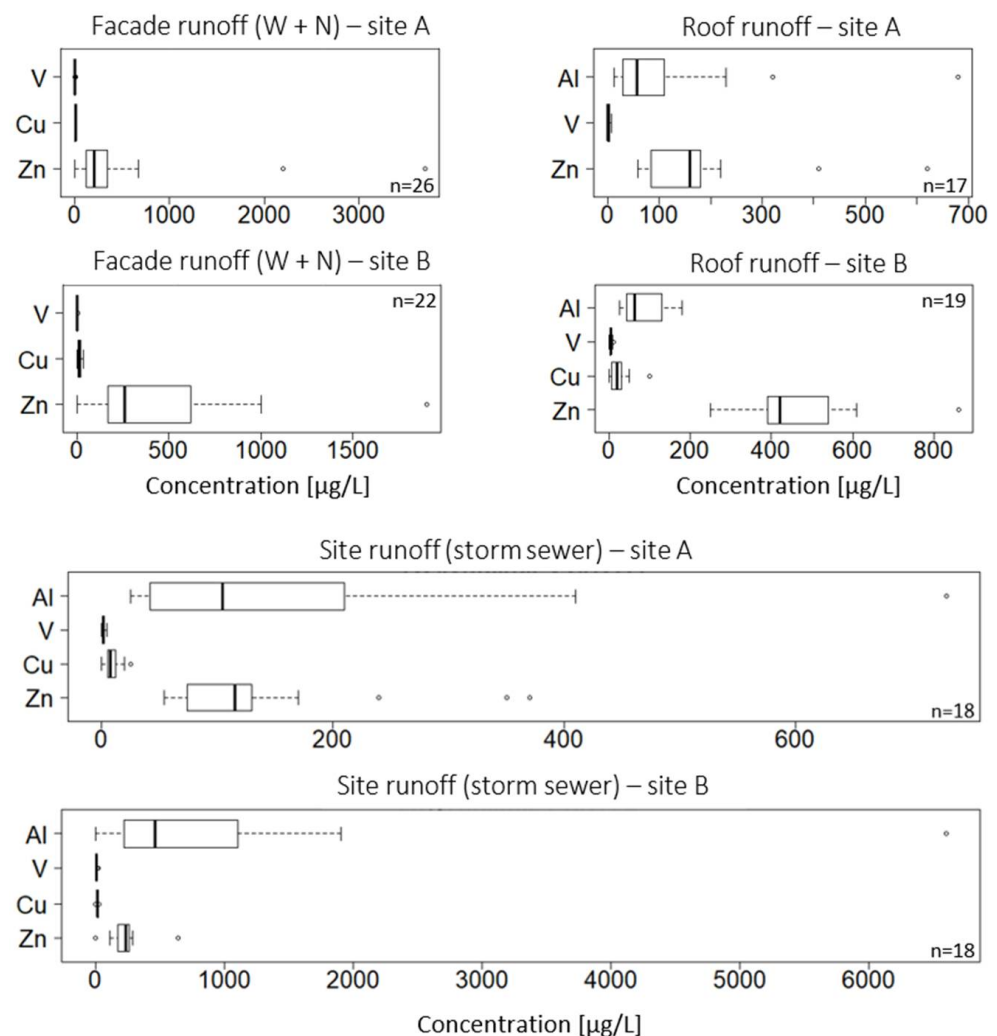
**Figure 5.** Concentrations of heavy metals in runoff of façades and roofs and in site runoff of site A and site B.

The concentrations of heavy metals are shown in Figure 5. For both sites, the highest concentrations were found for zinc and aluminium. Surprisingly high zinc concentrations occurred in the façade runoff, with mean values of 610  $\mu\text{g/L}$  (site A) and 460  $\mu\text{g/L}$  (site B) and a maximum value of 3700  $\mu\text{g/L}$ . Therefore, a release of zinc from plaster and paint is likely caused by the use of zinc oxide. In roof runoff, zinc can be emitted by gutters, galvanized smoke ventilation pipes, and roof edge cover sheets made of zinc. Higher roof runoff concentrations for zinc at site B (mean 500  $\mu\text{g/L}$ ) in comparison with site A (mean 180  $\mu\text{g/L}$ ) are attributed to the different materials used for the roof edge coverings (site B—zinc; site A—aluminium), highlighting the relevance of roof materials for zinc loads in stormwater runoff. For site runoff (storm sewer samples), zinc inputs resulted in mean zinc concentrations of 240  $\mu\text{g/L}$  for site B (max: 640  $\mu\text{g/L}$ ) and 135  $\mu\text{g/L}$  (max: 370  $\mu\text{g/L}$ ) for site A. These are comparable to the zinc concentrations in stormwater runoff of residential areas in Berlin (150 and 260  $\mu\text{g/L}$  in runoff from catchments comprising of concrete slab buildings and one family homes [11]) and in France (210  $\mu\text{g/L}$  [12]).

The dissolved fraction of zinc in this study is in average 60% and of aluminium 15%. Thus, zinc concentrations in the site runoff clearly exceeded the EQS proposal for dissolved zinc of 33  $\mu\text{g/L}$  [21]. Load estimations indicate that zinc in roof runoff contributes >90% (site A) and 50% (site B) to the total zinc mass in the stormwater sewer. At site B, in addition to roof inputs, zinc sheet windowsills and possible traffic-related zinc inputs from a small residential street are additional plausible sources. At site B, high concentrations of aluminium were detected with a mean concentration in site runoff of 960  $\mu\text{g/L}$  (max: 6600  $\mu\text{g/L}$ ). The sources for aluminium could not be fully clarified. However, in contrast with zinc, the ecotoxicological relevance of this metal is significantly lower.

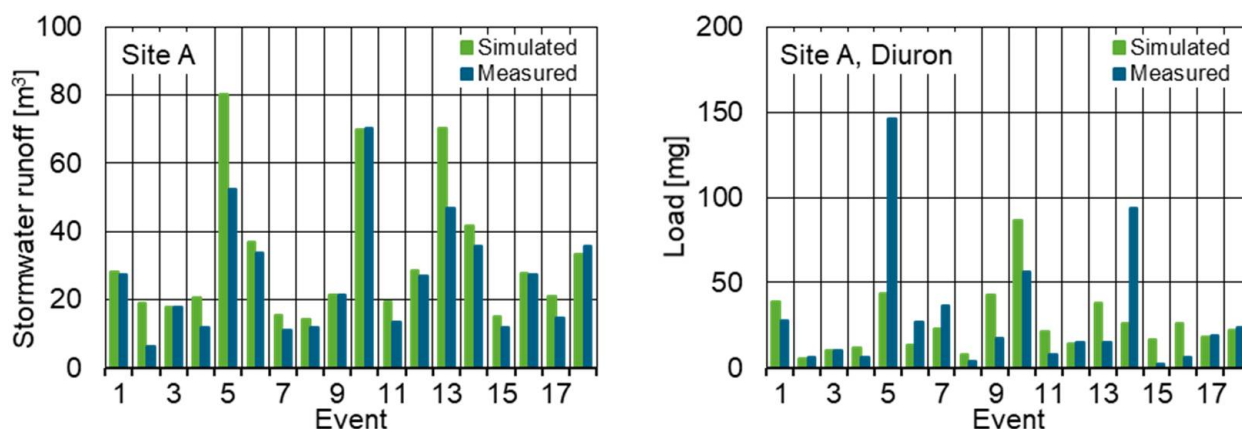
**Figure 6.** Measured and simulated stormwater runoff (left) and diuron load (right) in the stormwater of the entire catchment of site A for 18 analysed events.

The simulated runoff volume in the storm sewer, draining the associated surfaces of the entire catchment area, corresponds to about 120% of the measured volume and originates for 30% from open spaces and paths and >60% from roofs (Figure 6). The percentage of area connected to the storm sewer was estimated in the field study and adopted in the model accordingly. Façade runoff is negligible in terms of volume, accounting for 0.02% of the total runoff, with the east façades (2200  $\text{m}^2$ ) contributing 65%, followed by the south (1850  $\text{m}^2$ ) and west (1250  $\text{m}^2$ ) façades, each contributing 8%. The overestimation of the runoff volumes in the stormwater sewer is based firstly on two large individual rain events, and secondly on the generic runoff coefficients defined in the model for all surfaces, which are likely to deviate from reality (Figure 6).

For the modelling of the substance emission, lab data (prEN 16637-2:2021) of the same render used at site A was used to parametrize the emission function. The modelled emission underlines the strong relevance of the façade orientation. In fact, 75% of the total emitted diuron load of the catchment originates from the west and south façades (Figure 7, right). The modelled diuron load of all façade surfaces draining into the stormwater channel is only about 9% below the load estimated from measured data (476 vs. 522 mg).

The difference can again be attributed to two rain events with measured values being about five times higher than the simulated concentrations (Figure 6). However, diuron entered the storm sewer primarily from the east façades, as these have the highest percentage of area being in connection with the storm sewer through sealed and drained surfaces (Figure 7).

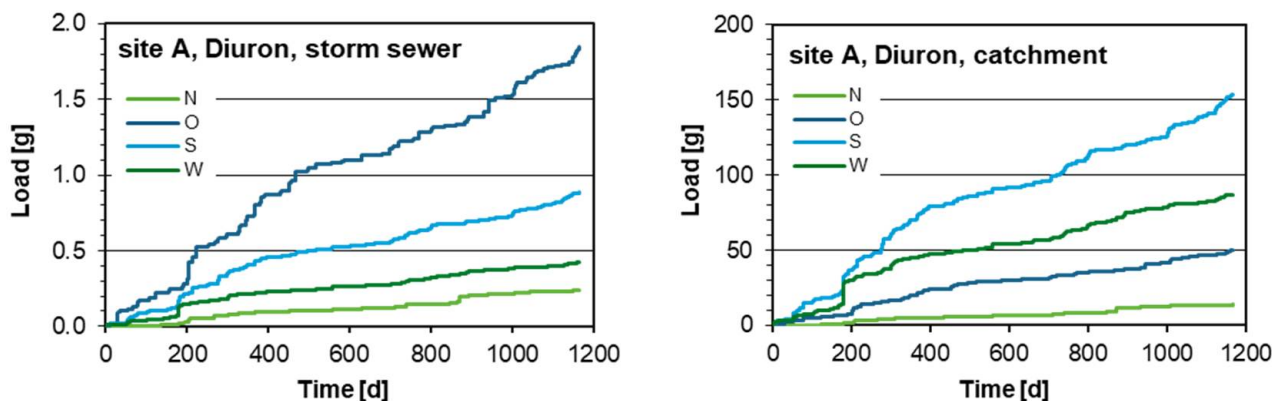
**Figure 7.** Cumulative exposure-dependent diuron load of all building façades in connection with the storm sewer (**left**) and of all façades of site A (**right**). The scenario-based simulations cover 3 years starting with the construction of the site.

The total catchment emissions of diuron were calculated for a time period of three years by cumulating emissions of single events for all façades, regardless of their connection to the storm sewer. This model-based, exposure-dependent emission estimation at site A shows that the modelled diuron load (3.4 g) in the storm sewer is about 100 times smaller than the total emission from all façades of the site (305 g) (Figure 7). Thus, the difference between the emission into the sewer and the total emission indicates that only 1% of the amount of biocide washed out enters the stormwater sewer, which discharges into River Spree, while 99% of the load remains on site. The 305 g diuron emission corresponds to 6950 m<sup>2</sup> of façades, resulting in an average release of 43.9 mg/m<sup>2</sup> in 3 years with decreasing emission rate over time.

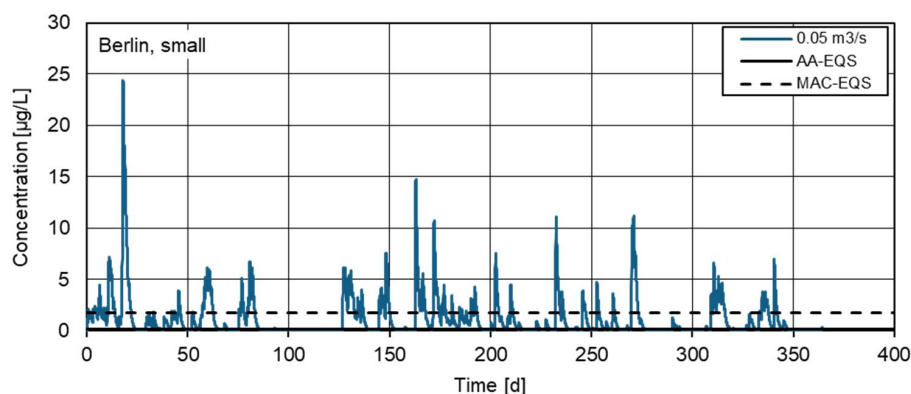
**Figure 8.** Simulated concentration of diuron in a small brook (0.05 m<sup>3</sup>/s) in Berlin over a period of 1 year.

To estimate the possible impact of the diuron emission on a receiving surface water, another scenario was calculated, assuming that 100% of the façade runoff is directly discharged into a surface water with a flow of 50 L/s (worst case scenario). Results show that the total diuron emissions are significant as these result in concentrations that exceed the EQS for surface waters (Figure 8). Based on the presented scenario, it is clear that peak concentrations occur during most wet weather flows at least within the first year after construction. Especially in small water bodies (50 L/s), the duration and number of possible exceedances increase disproportionately than in larger ones (500 L/s).

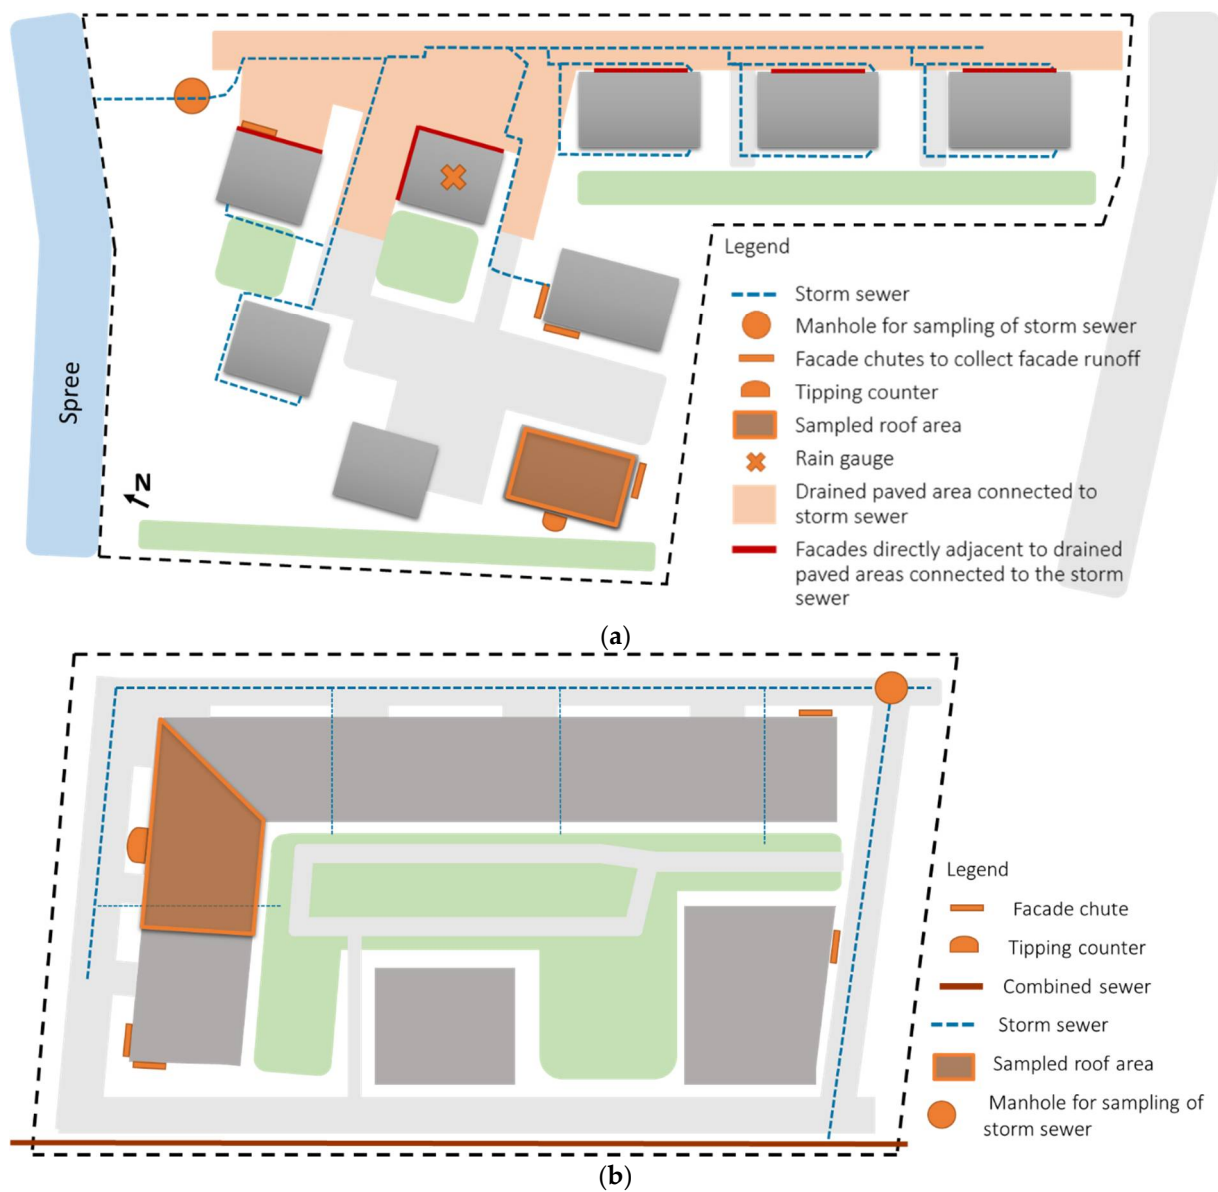
**Figure A1.** Schematic view of test site A (a) and test site B (b).

Two new development sites (site A and B, about 120 apartments each) were selected in Berlin (Germany), both constructed in 2017 (1–1.5 years prior to the start of the monitoring campaign). The total catchment area is 12,500 m<sup>2</sup> for site A and 6000 m<sup>2</sup> for site B. The catchments represent typical architecture for multi-storey apartment buildings with a separated sewer system. Both sites include plastered and painted façades (external thermal insulation composite system) and flat roofs covered with bituminous sheets, combined with extensive green roofs at site B. Several components are assembled by zinc or aluminium metal sheets. A schematic view of the test sites with stormwater sewers and location of sampling points is shown in Figure A1.

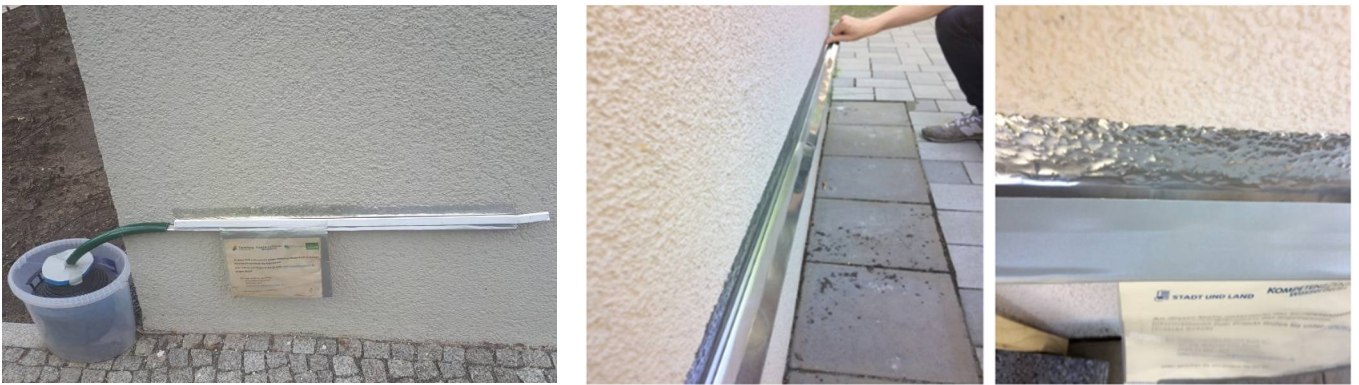
Figure A2. Installation of a gutter to capture façade runoff.

Façade runoff was captured at four points per site covering all four cardinal directions. Runoff was collected using 1 m long aluminium gutters connected to 10–20 L glass bottles. In order to minimize direct rainfall into the gutters, the opening was covered leaving a gap to the façades of 2 mm (Figure A2). The gutters were firmly attached to the façade with a flexible tape, allowing runoff to enter the gutters despite the roughness of the plaster. For each storm event, specific façade runoff was quantified by dividing the volume collected in the bottle by the façade area above the gutter.

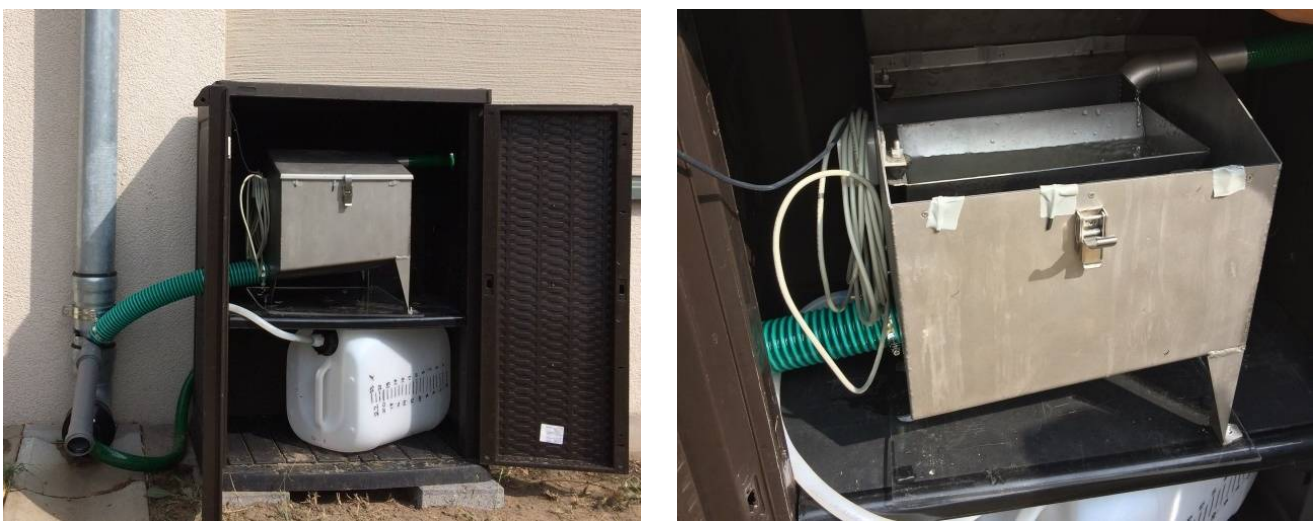
Figure A3. Tipping counter for measurement and sampling of roof runoff.

At both sites, roof runoff was quantified by diverting the full flow of one downpipe into a stainless steel tipping counter (Umwelt-Geräte-Technik GmbH, Müncheberg, Germany) with tipping tray volumes of 2 L (site A) and 1 L (site B). Discharge was logged in 5 min intervals. A proportion of 0.5% of each tipping volume was diverted to a sampling container in order to collect a volume-proportional sample for each storm event (Figure A3). Calibration of the tipping and sampling mechanisms was conducted in field conditions prior to installation. Specific roof runoff for each event was computed by dividing the total logged volume by the connected roof area.

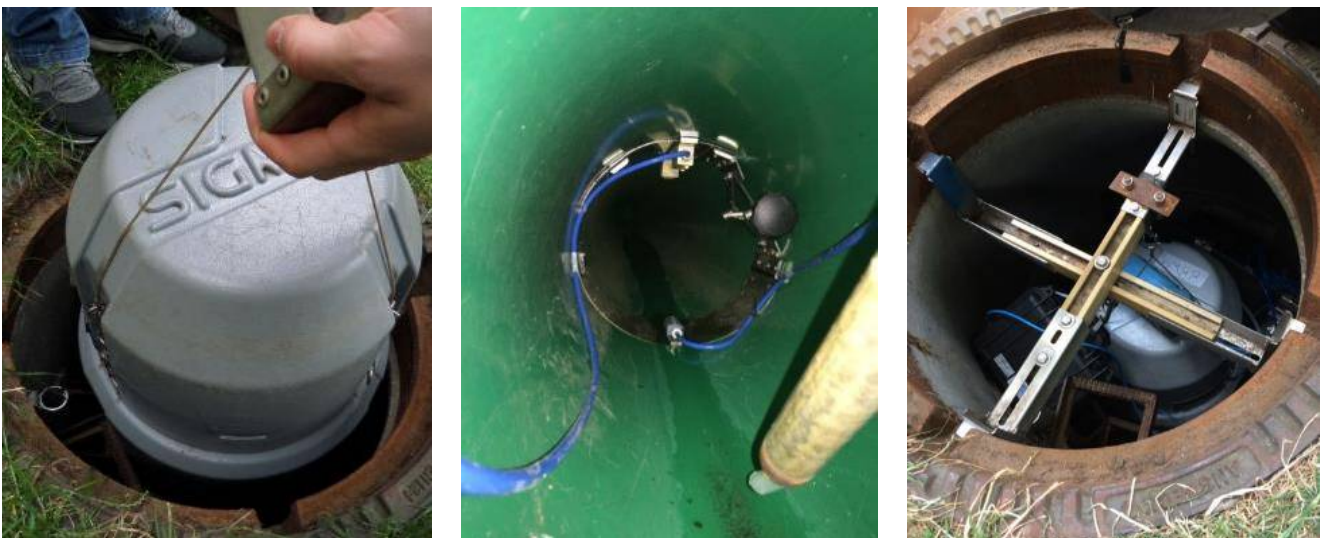
Figure A4. Installation of an automatic sampler and flow measuring device in a storm sewer and a manhole.

The stormwater runoff was sampled near each site's catchment outlet. Flow meters (ultrasound and cross-correlation sensors, PCM4 logger, Nivus, Eppingen, Germany) and portable automatic samplers (Sigma SD 900, Hach Lange, Düsseldorf, Germany) equipped with glass bottles ( $8 \times 2$  L) were installed in a manhole receiving runoff from the entire catchment (A and B, respectively) (Figure A4). The samplers were triggered by a preassigned water level threshold. Volume-proportional composite samples were prepared based on runoff measurements (for details see [11]) to determine the event mean concentrations (EMC).

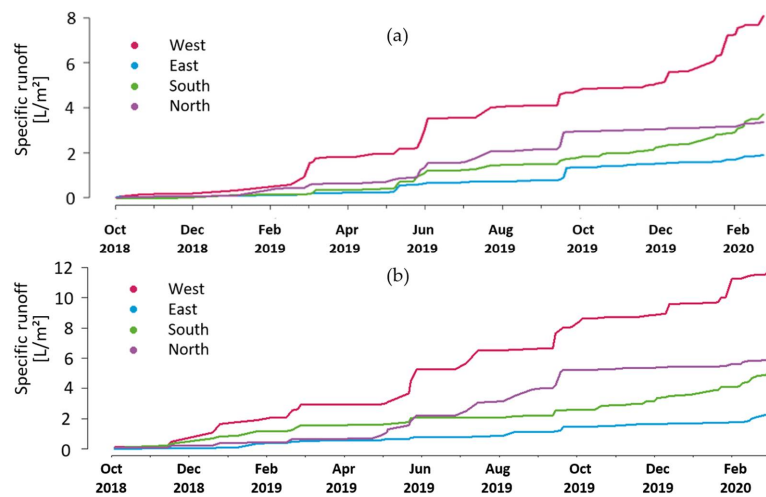
**Figure A5.** Cumulated specific façade runoff for site A (a) and site B (b).

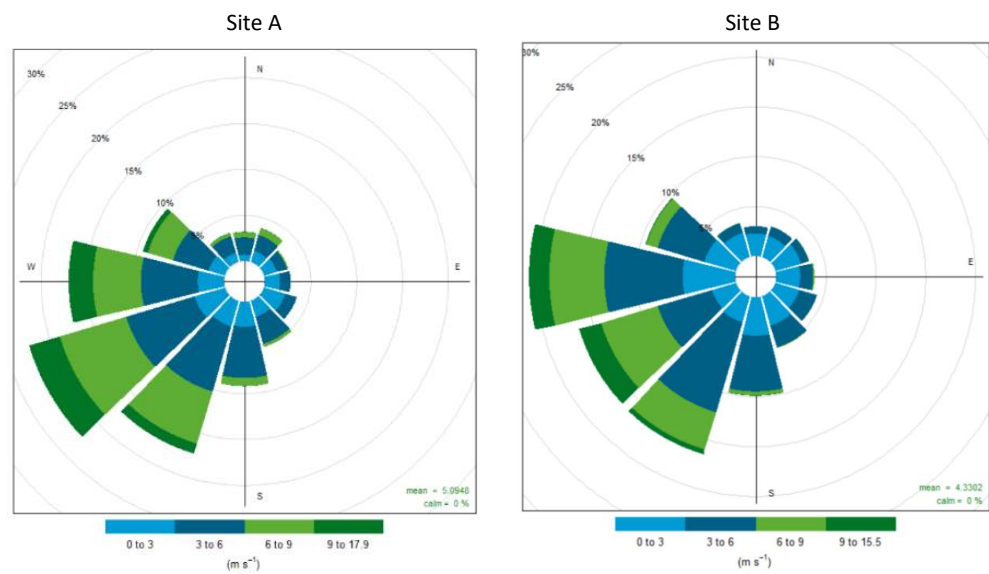
**Figure A6.** Wind speed and wind directions for all sampled events at test sites A and B.

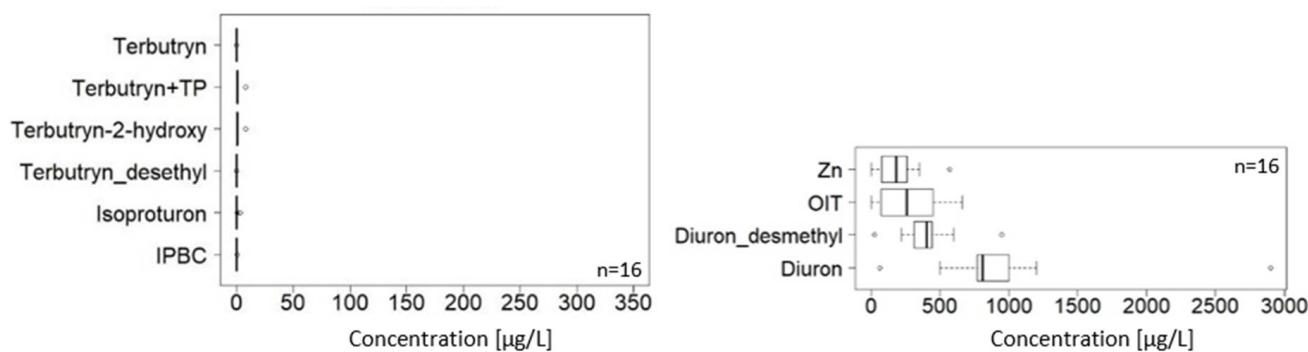
Figure A7. Concentrations of biocides in façade runoff from west façades at test site A.

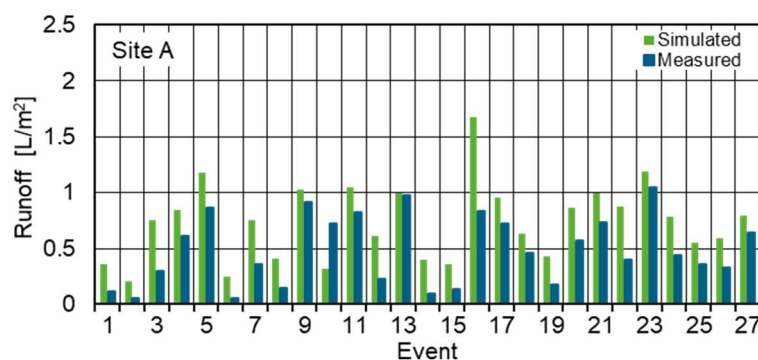
Figure A8. Measured and simulated façade runoff of buildings at test site A and site B for 27 and 26 events, respectively. Events with more than 10 mm rainfall were taken into account as a basis for the prediction.

First, façade runoff was modelled considering the local weather data for the monitoring time period and the same façade area and orientation as the sampled façades in the field study. The predicted runoff from all building façades shows high agreement with the measured pattern of events, both in terms of variability and runoff amounts (Figure A8). For site A, the simulated runoff, cumulative over 1.5 years, is 12.5  $\text{L/m}^2$  compared with the measured runoff of 8.4  $\text{L/m}^2$ . The overestimation in the range of 30% is mainly associated with 3 heavy rain events of >30 mm each. If these data points were not considered, the deviations would amount to <10%. During these rain events, the effective wind field was different from that at the weather station about 1 km away. Shading by trees, bushes, or neighbouring buildings and local turbulences could have caused further deviations, which can only be roughly described with hourly resolved measurement data.
